Rocky Flats Environmental Technology Site

RECONNAISSANCE LEVEL CHARACTERIZATION REPORT (RLCR) SUPPLEMENT

771 CLOSURE PROJECT

REVISION 0

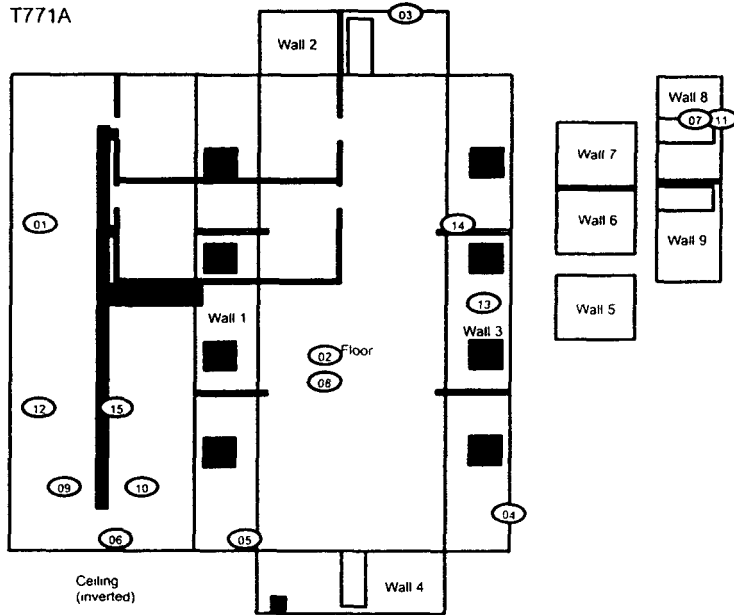
SURVEY UNIT 771002 - MAP 1 OF 1

Survey Area AJ Survey Unit 771002 Classification 3
 Building T771A
 Survey Unit Description T771A Interior
 Total Floor Area 127 sq m Total Area 396 sq m Grid Size N/A

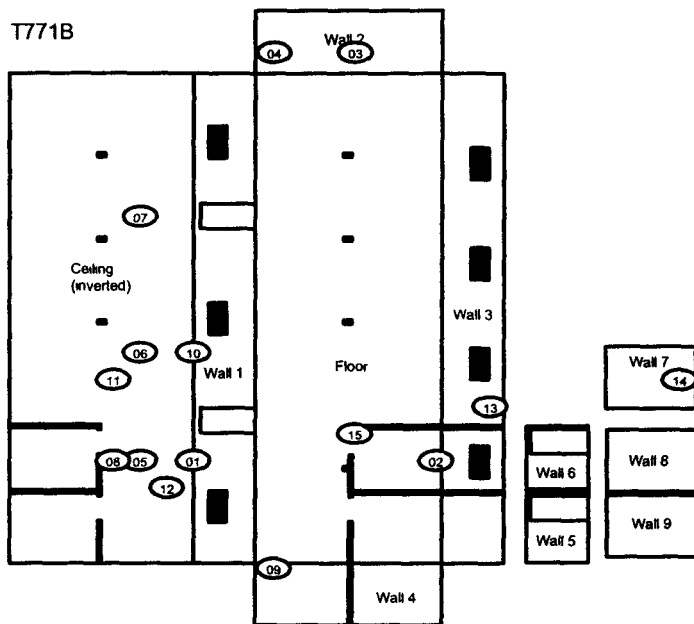
SURVEY UNIT 771003 - MAP 1 OF 1

Survey Area AJ Survey Unit 771003 Classification 3
 Building T771B
 Survey Unit Description T771B Interior

Total Floor Area 122 sq. m Total Area. 386 sq m Grid Size N/A

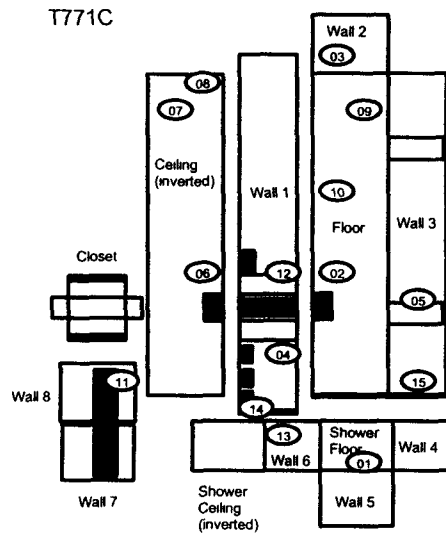
SURVEY UNIT 771004 - MAP 1 OF 1

Survey Area AJ Survey Unit. 771004 Classification 3
 Building T771C
 Survey Unit Description T771C Interior
 Total Floor Area 37.3 sq m Total Area 159 sq m Grid Size N/A

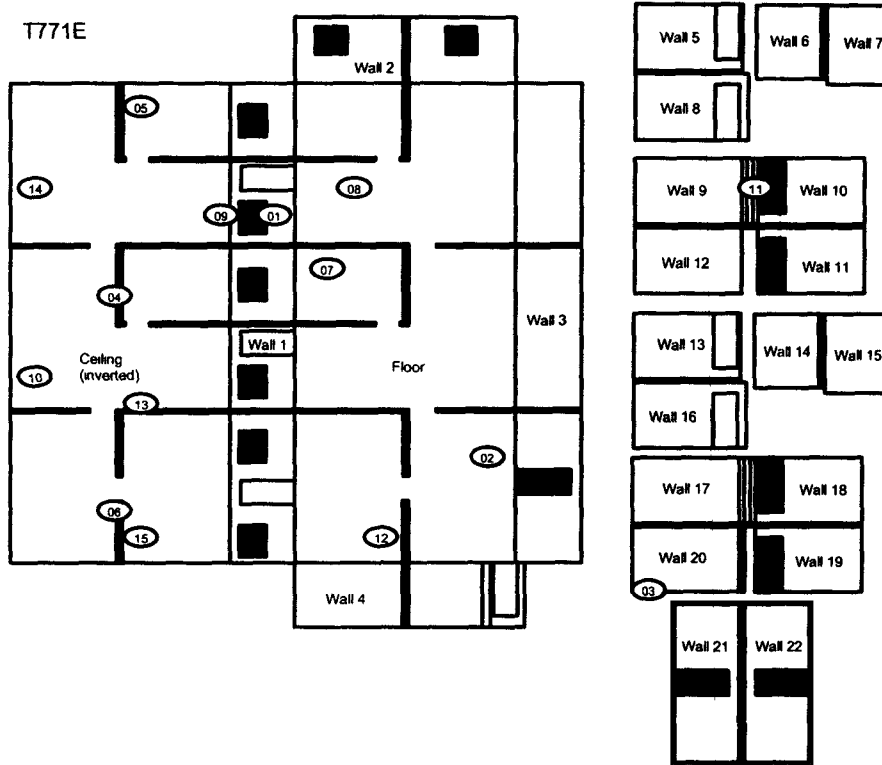
SURVEY UNIT 771005 - MAP 1 OF 1

Survey Area AJ Survey Unit 771005 Classification 3
 Building T771E
 Survey Unit Description T771E Interior
 Total Floor Area 141 sq m Total Area 563 sq m Grid Size N/A

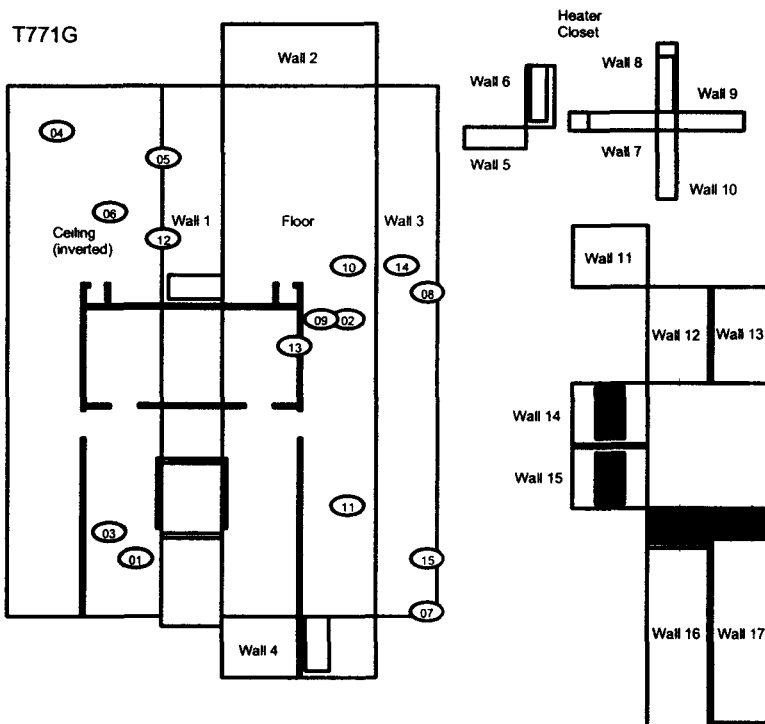
SURVEY UNIT 771006 - MAP 1 OF 1

Survey Area AJ Survey Unit. 771006 Classification 3
 Building T771G
 Survey Unit Description T771G Interior
 Total Floor Area 112 sq m Total Area 418 sq m Grid Size N/A

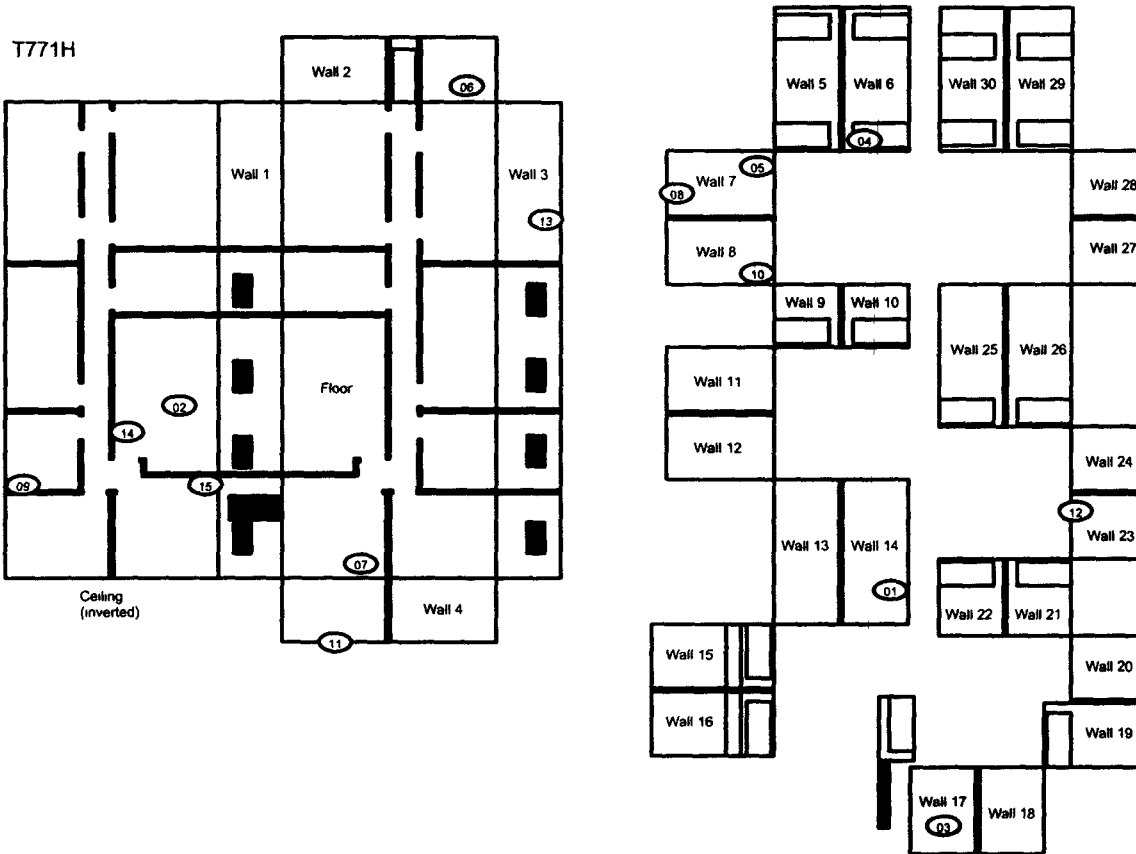
SURVEY UNIT 771007 - MAP 1 OF 1

Total Floor Area 140 sq m Total Area 651 sq m Grid Size N/A

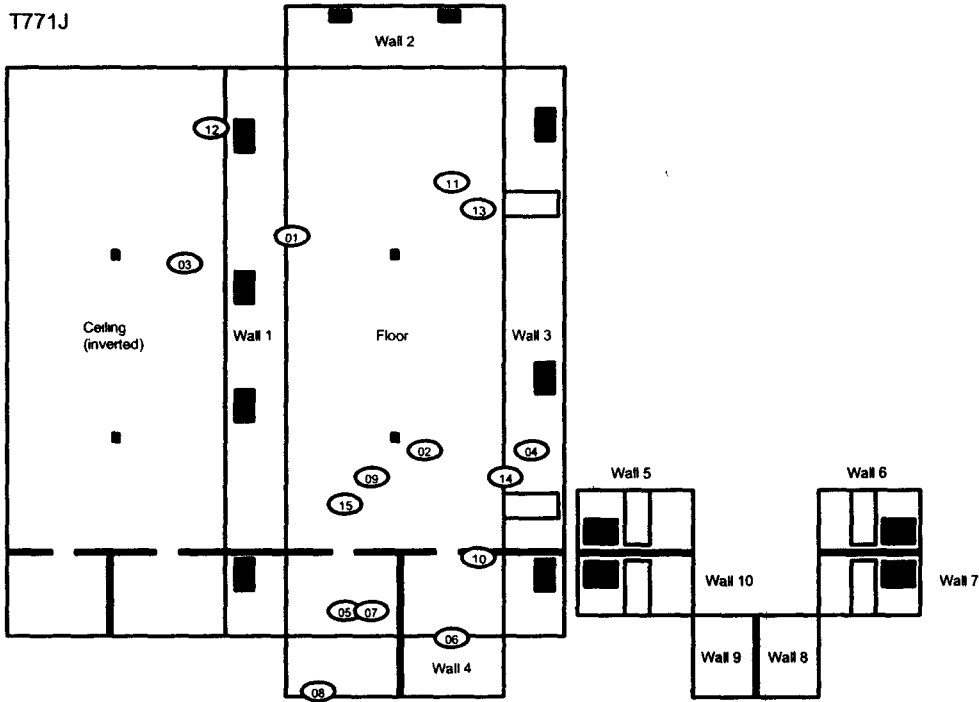
SURVEY UNIT 771008 - MAP 1 OF 1

Survey Area AJ Survey Unit. 771008 Classification 3
 Building T771J
 Survey Unit Description T771J Interior
 Total Floor Area 170 sq m Total Area 512 sq m Grid Size N/A

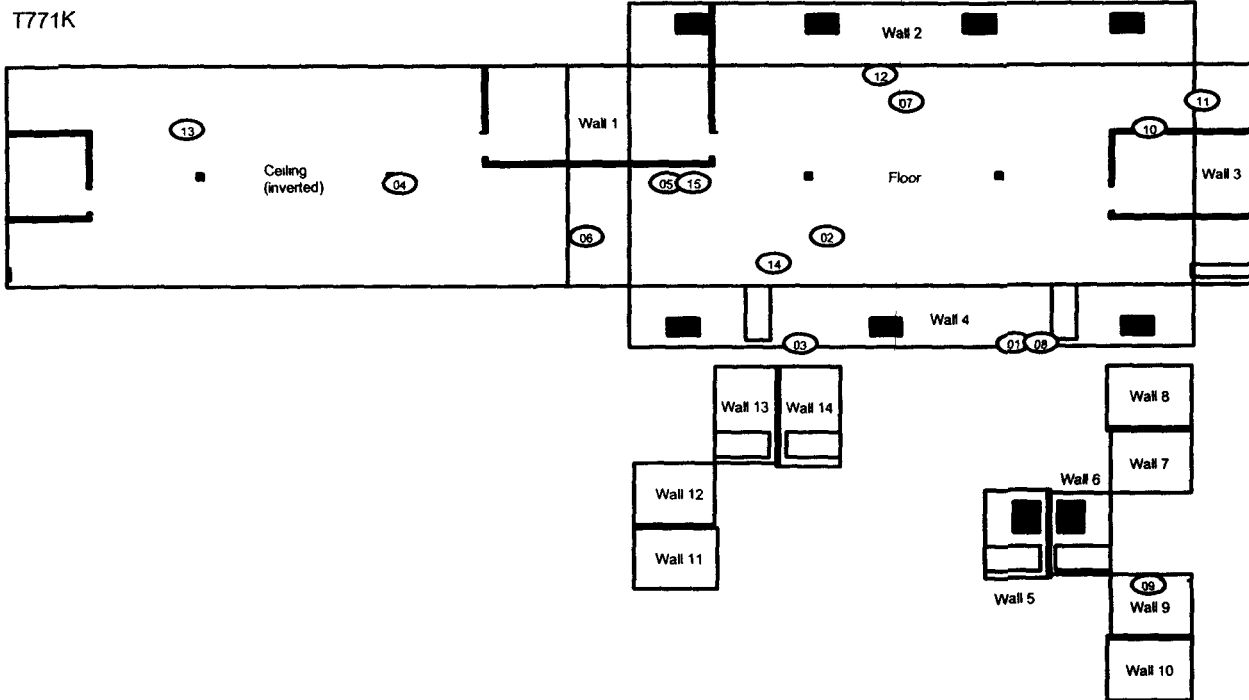
SURVEY UNIT 771009 - MAP 1 OF 1

Survey Area AJ Survey Unit: 771009 Classification 3
 Building T771K
 Survey Unit Description T771K Interior
 Total Floor Area 169 sq m Total Area 537 sq m Grid Size N/A

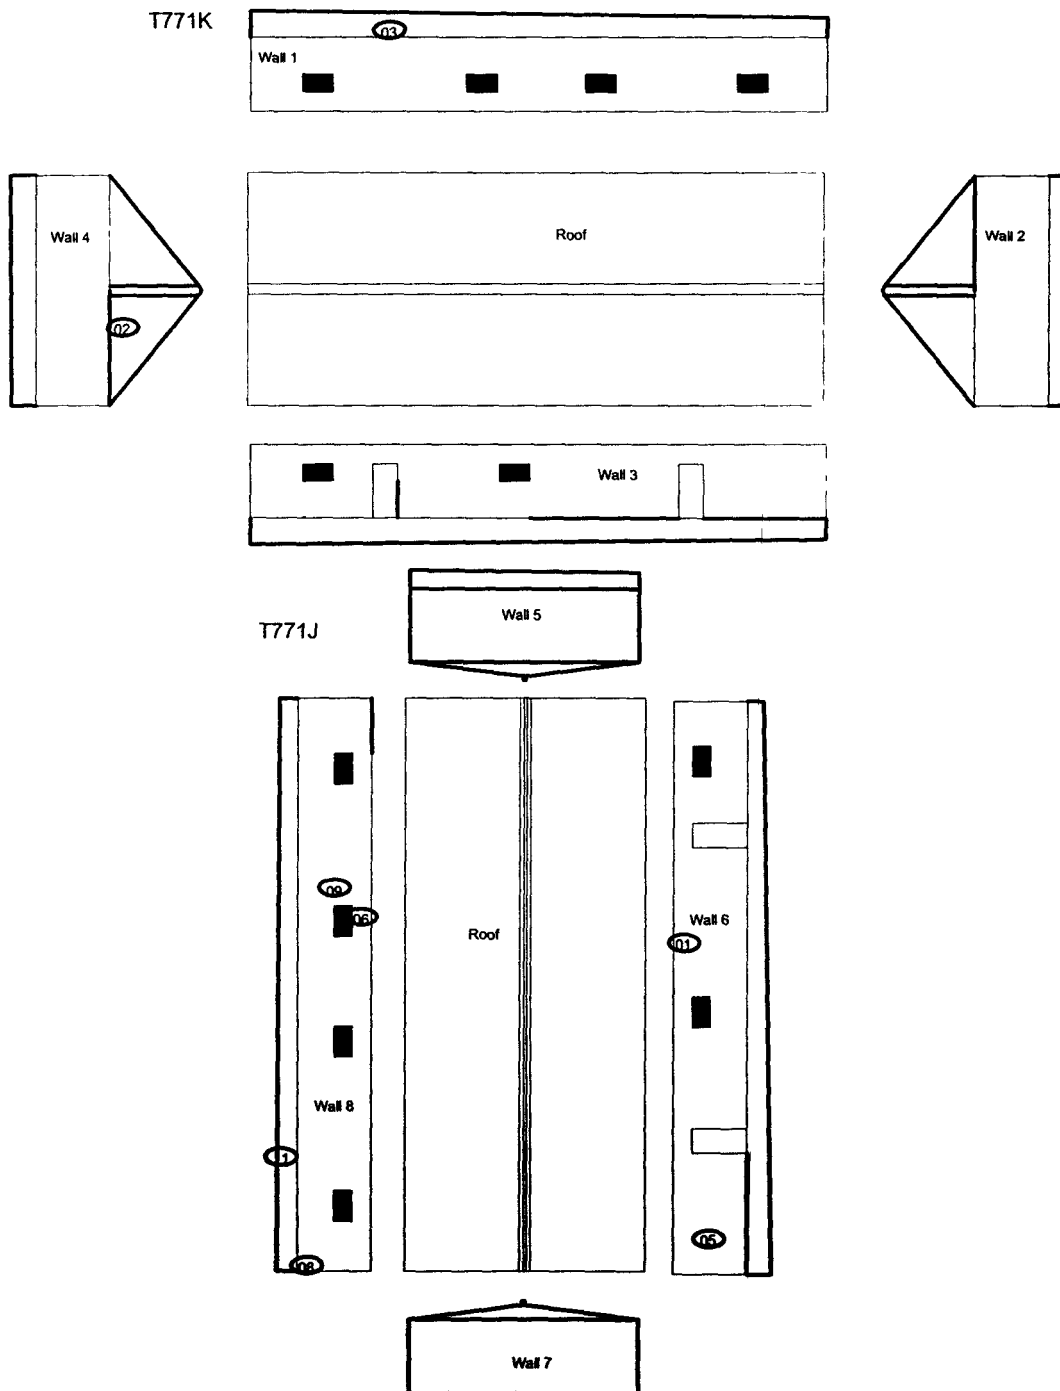
SURVEY UNIT 771010 - MAP 1 OF 2

Survey Area Survey Unit: 771010 Classification 2
 Building 771
 Survey Unit Description 771 Trailers K, J, E, H External Surfaces
 Total Floor Area NA sq m Total Area 1216 sq m Grid Size N/A

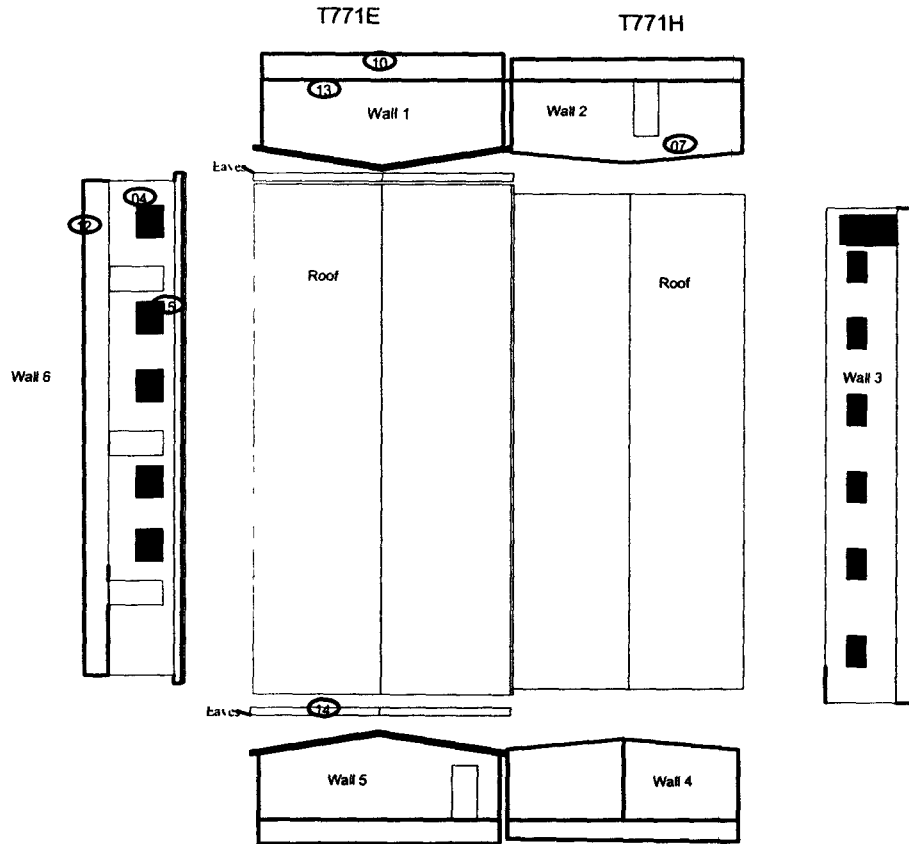
SURVEY UNIT 771010 - MAP 2 OF 2

Survey Area AJ Survey Unit. 771010 Classification 3
 Building 771
 Survey Unit Description 771 Trailers K, J, E, H External Surfaces
 Total Floor Area NA sq m Total Area 1216 sq m Grid Size N/A

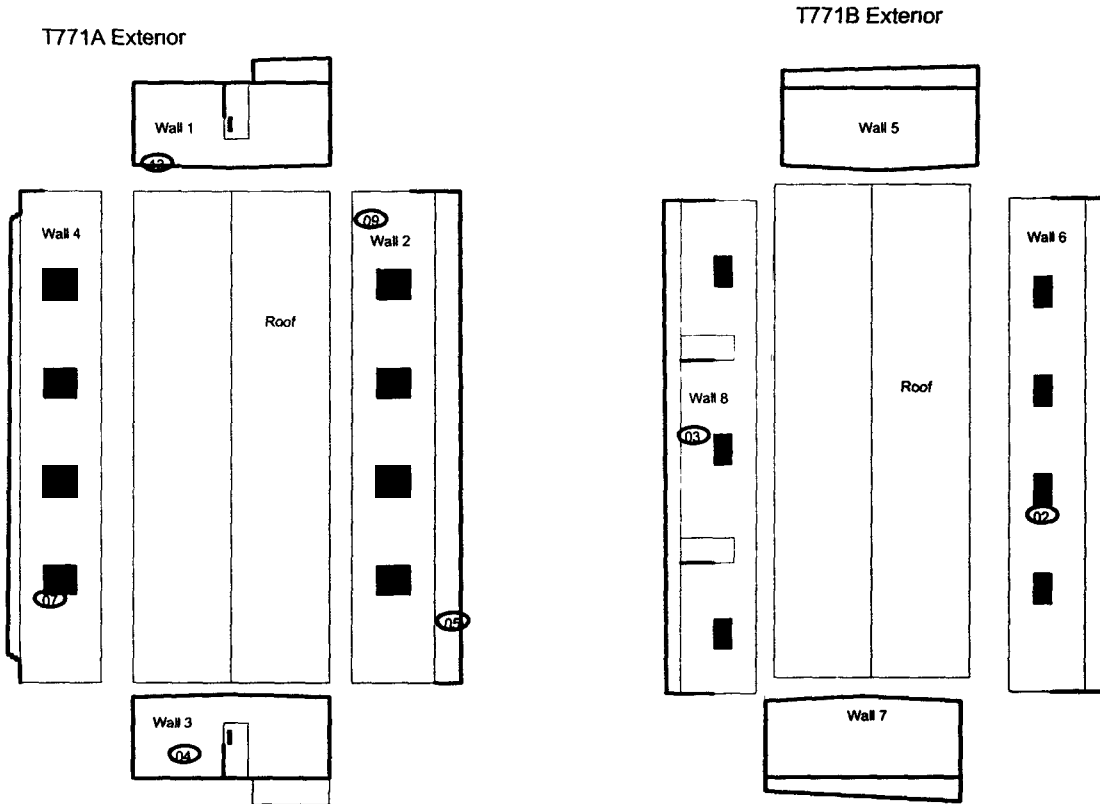
SURVEY UNIT 771011 - MAP 1 OF 2

Survey Area AJ Survey Unit. 771011 Classification 3
 Building T771 A, B, C, G
 Survey Unit Description T771 A, B Exterior
 Total Floor Area NA Total Area 1106 sq m Grid Size N/A

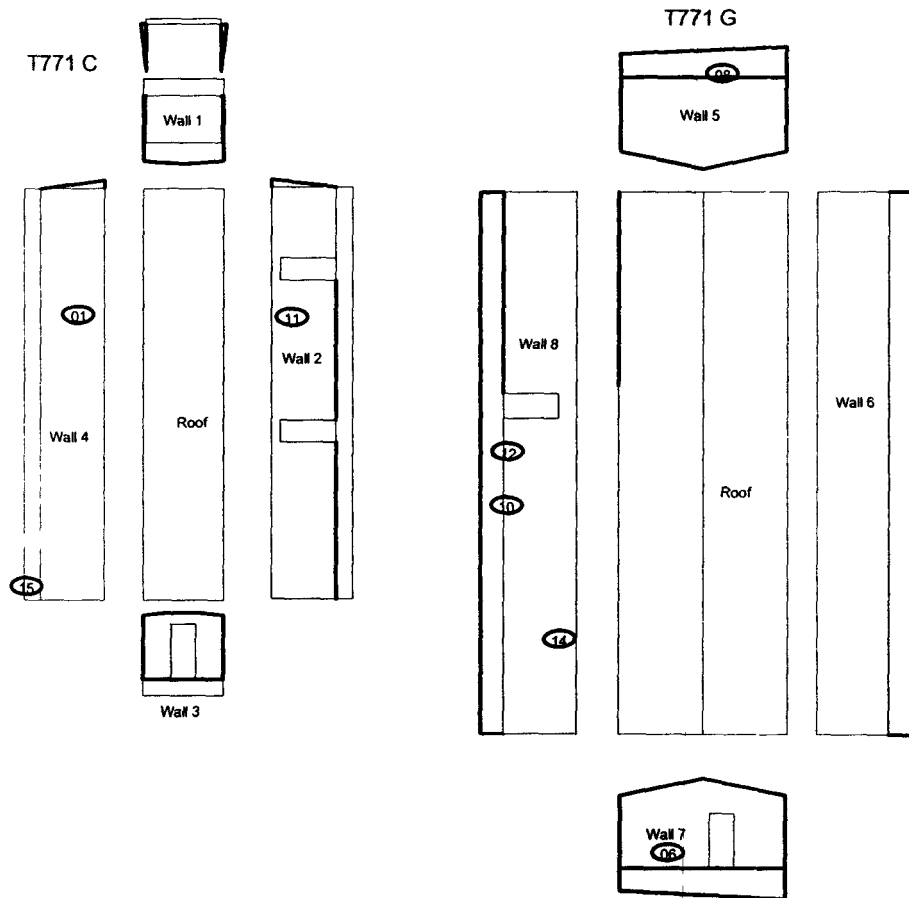
SURVEY UNIT 771011 - MAP 2 OF 2

Survey Area: AJ Survey Unit: 771011 Classification: 3
 Building: T771 A, B, C, G
 Survey Unit Description: T771 C, G Exterior
 Total Floor Area: NA Total Area: 1106 sq m Grid Size: N/A

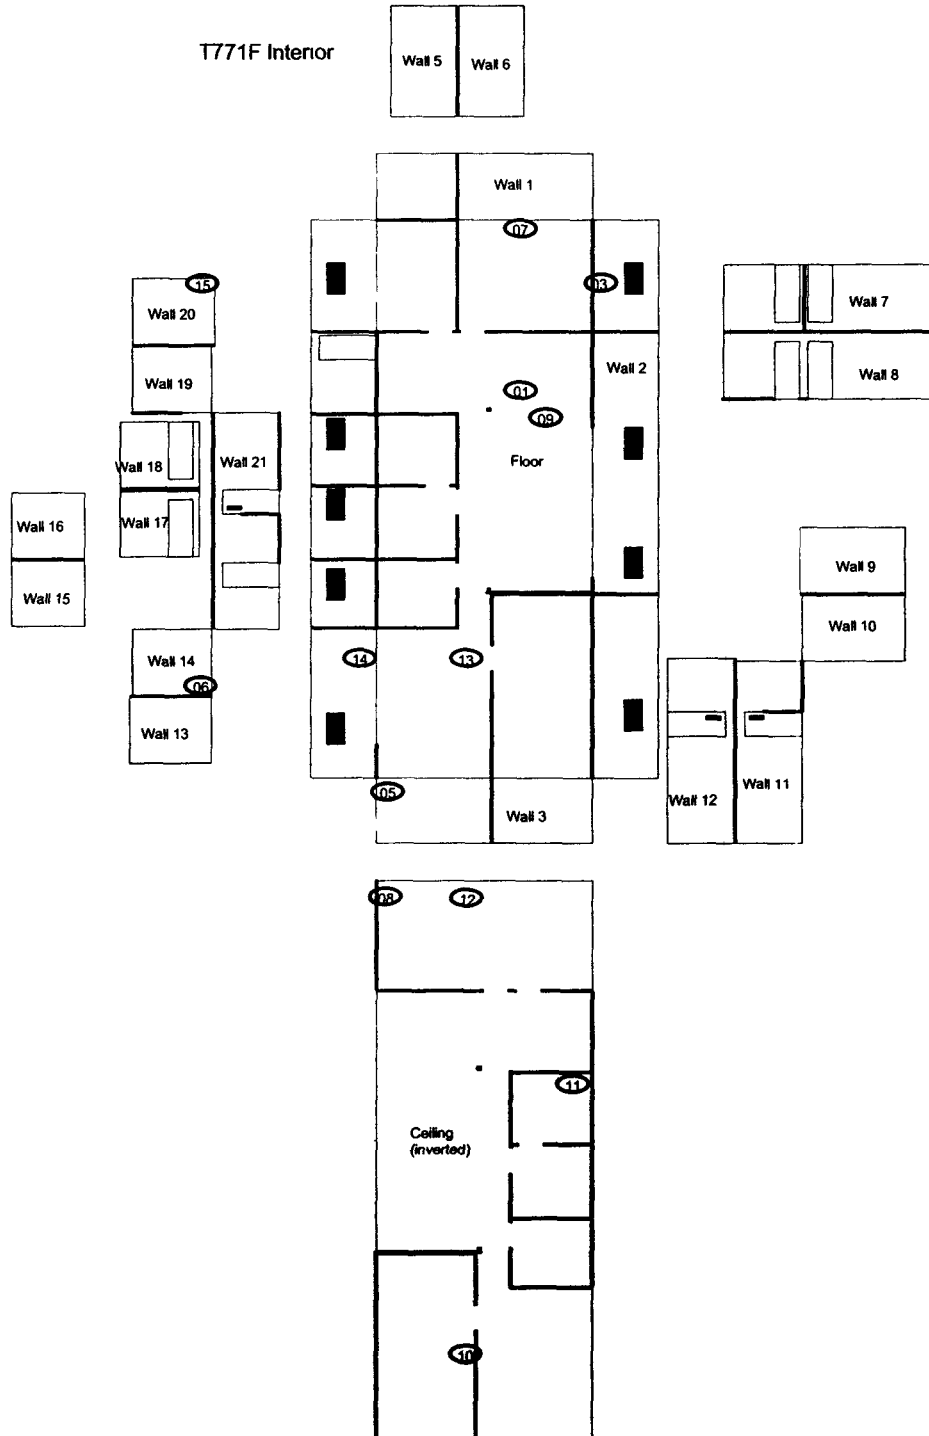
SURVEY UNIT 771012 - MAP 1 OF 2

Survey Area **AJ** Survey Unit. **771012** Classification **3**
 Building **771**
 Survey Unit Description **T771F Interior/Exterior**
 Total Floor Area **162 sq m** Total Area **1031 sq m** Grid Size **N/A**

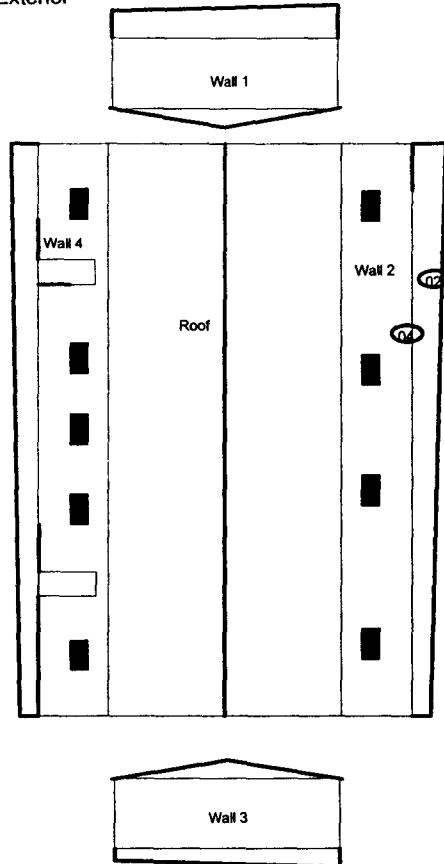
SURVEY UNIT 771012 - MAP 2 OF 2

T771F Exterior

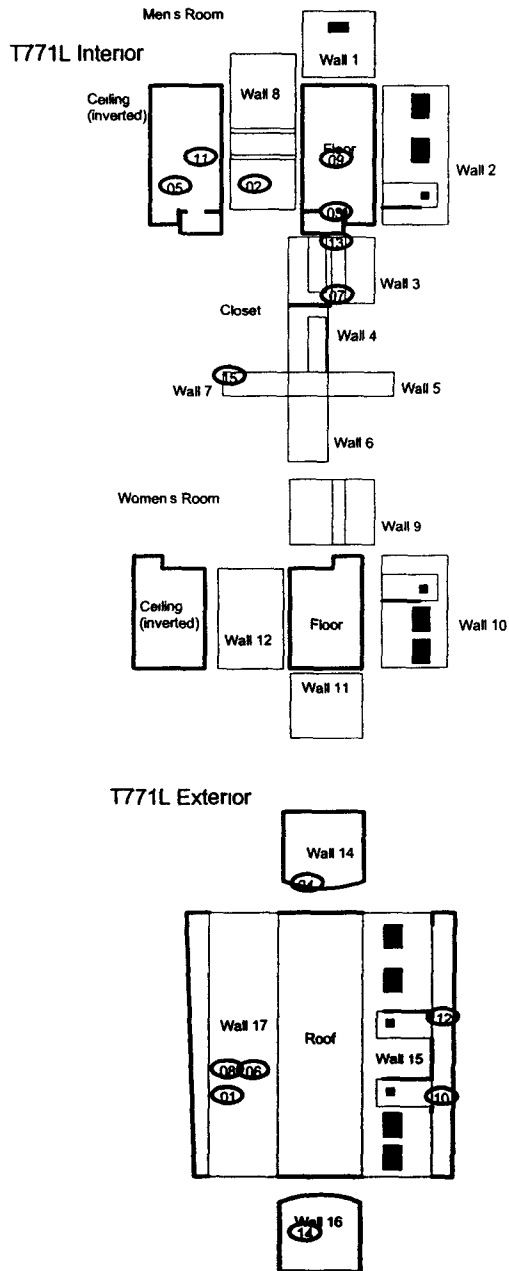
SURVEY UNIT 771013 - MAP 1 OF 1

Survey Area AJ Survey Unit: 771013 Classification 3
 Building 771
 Survey Unit Description T771L Interior/Exterior
 Total Floor Area 24 sq m Total Area 240 sq m Grid Size N/A

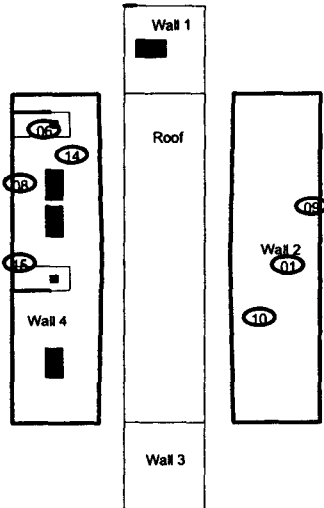
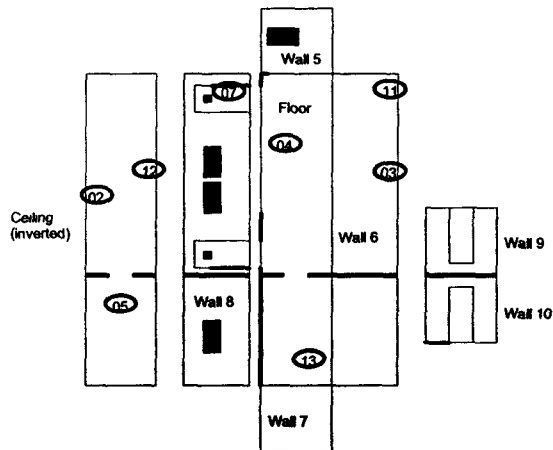
SURVEY UNIT 771014 - MAP 1 OF 1

T771MB Exterior

T771MB Interior

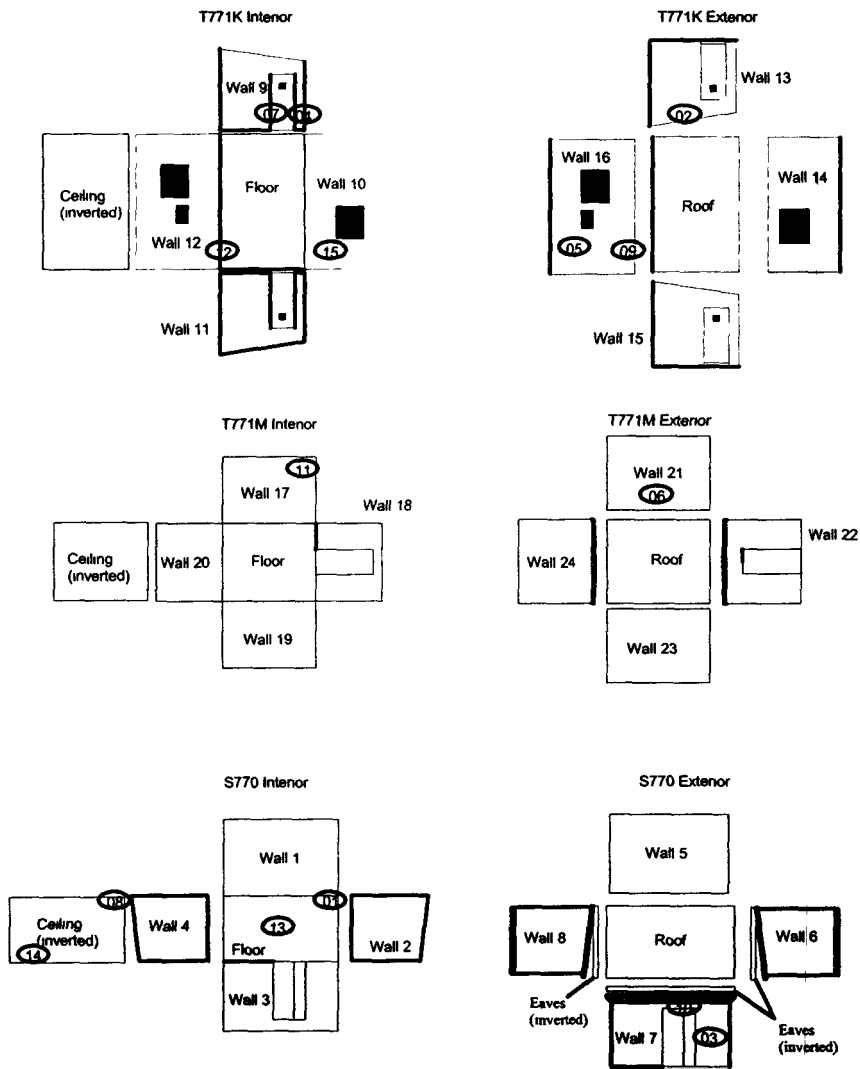
SURVEY UNIT 771015 - MAP 1 OF 1

Survey Area AJ Survey Unit. 771015 Classification 3
 Building T771M, T771K, S770
 Survey Unit Description Exterior/Interior
 Total Floor Area 35 sq m Total Area 349 sq m Grid Size N/A

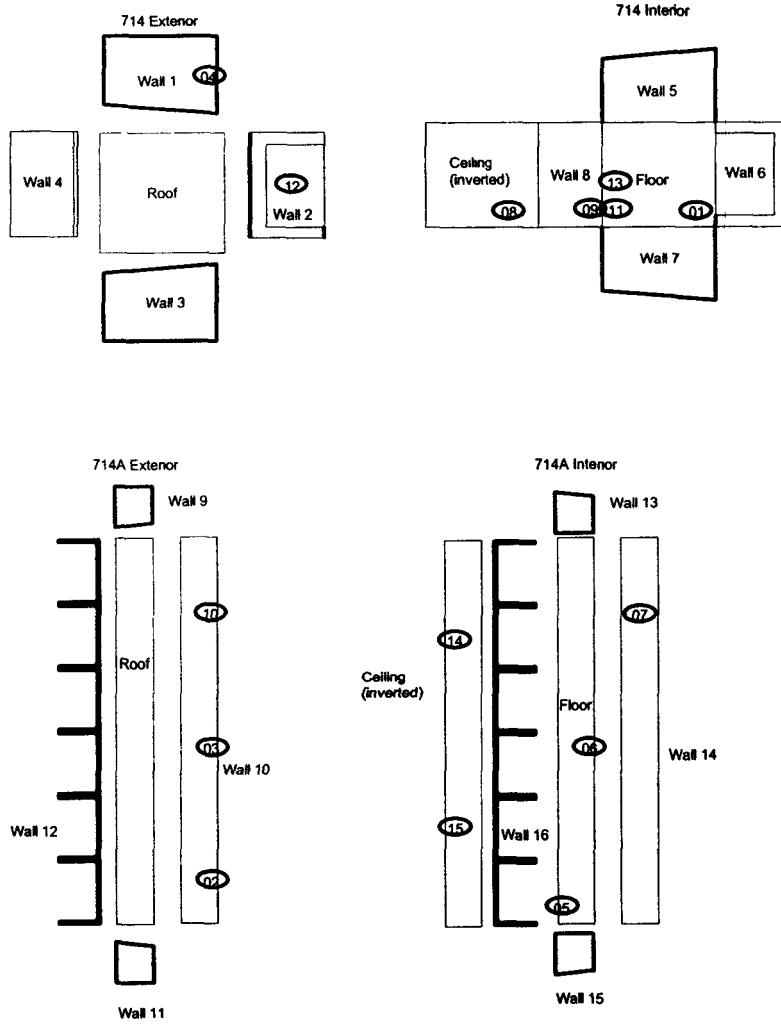
SURVEY UNIT 771016 - MAP 1 OF 1

Survey Area AJ Survey Unit: 771016 Classification 3
 Building 714/714A
 Survey Unit Description 714/714A Interior/ Exterior
 Total Floor Area 35 sq. m Total Area 248 sq m Grid Size N/A

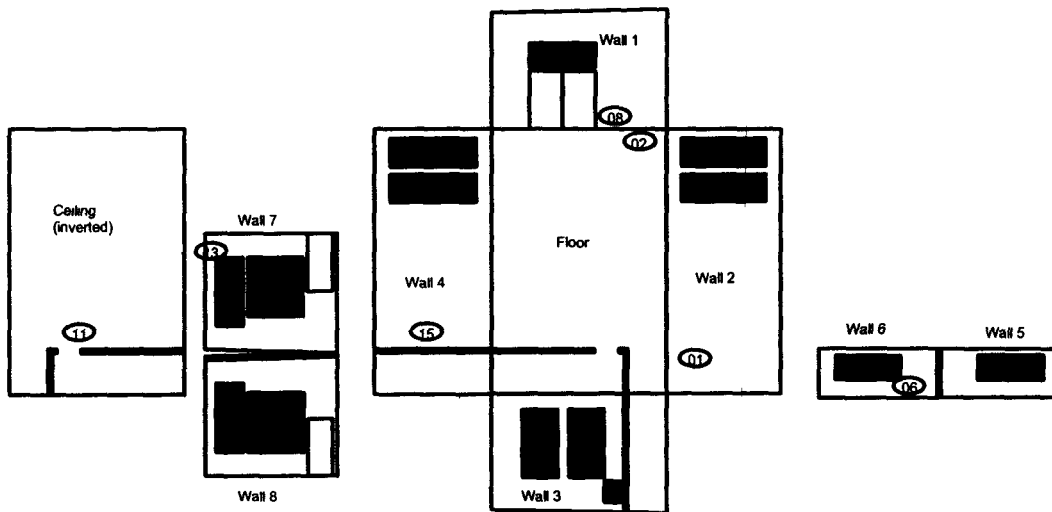
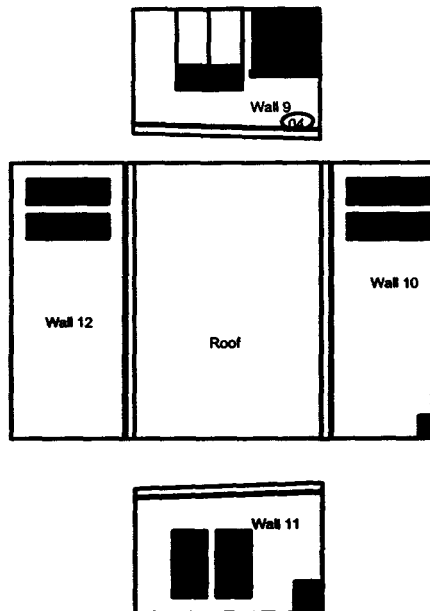
SURVEY UNIT 771017 - MAP 2 OF 2

Survey Area AJ Survey Unit: 771017 Classification 3
 Building 715
 Survey Unit Description 715, 716, 717 Exterior & Interior
 Total Floor Area 95 sq m Total Area 742 sq m Grid Size N/A

715 Interior

715 Exterior

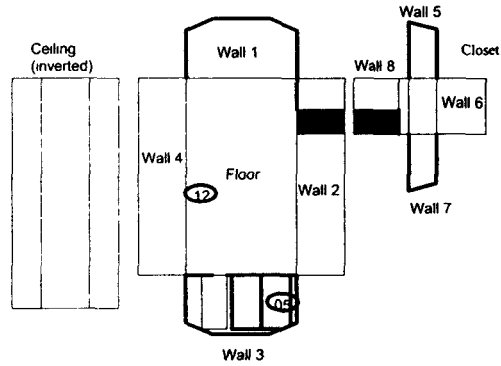
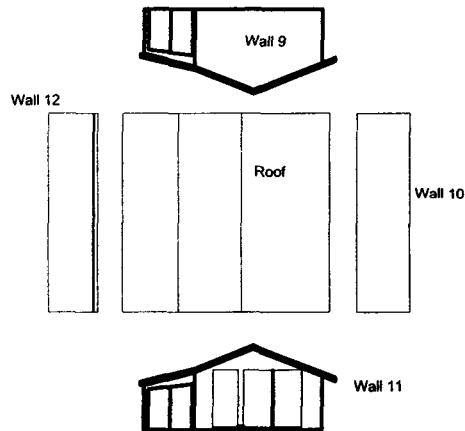
SURVEY UNIT 771019 - MAP 1 OF 4

771B Interior

771B Exterior

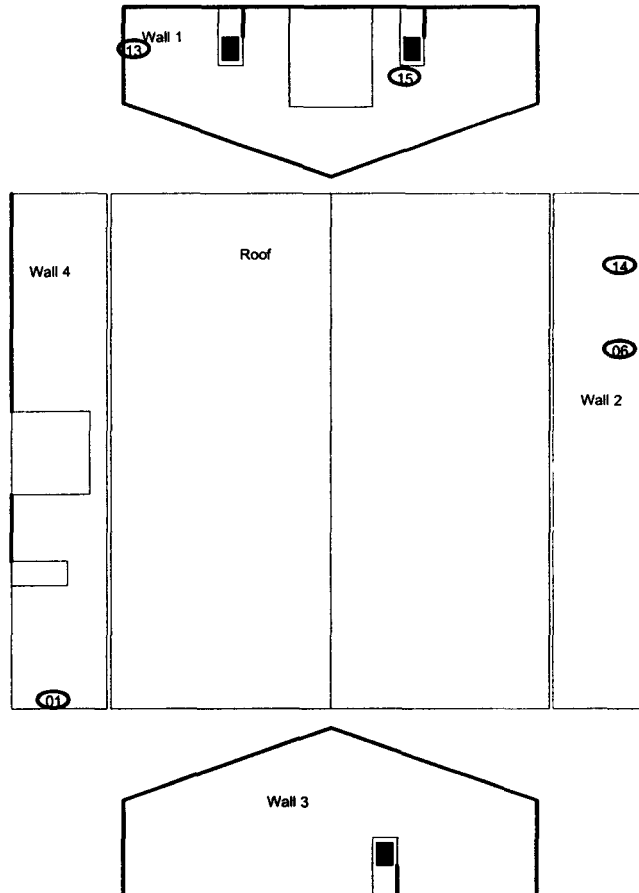
SURVEY UNIT 771019 - MAP 2 OF 4

770 Exterior

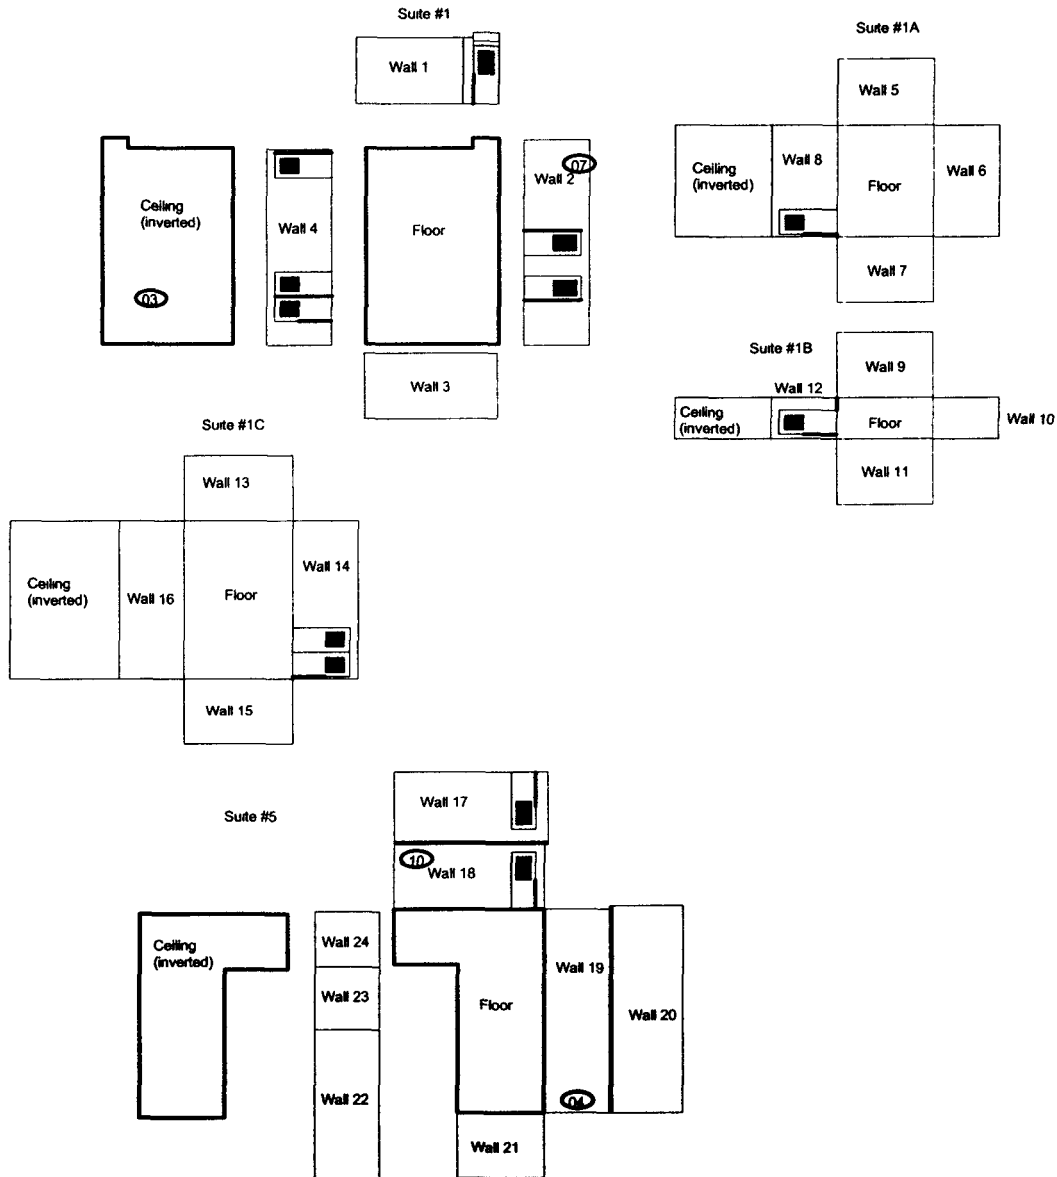
SURVEY UNIT 771019 - MAP 3 OF 4

Survey Area AJ Survey Unit: 771019 Classification 3
 Building 771B /770
 Survey Unit Description 770 Interior

Total Floor Area 303 sq m Total Area 2094 sq. m Grid Size N/A

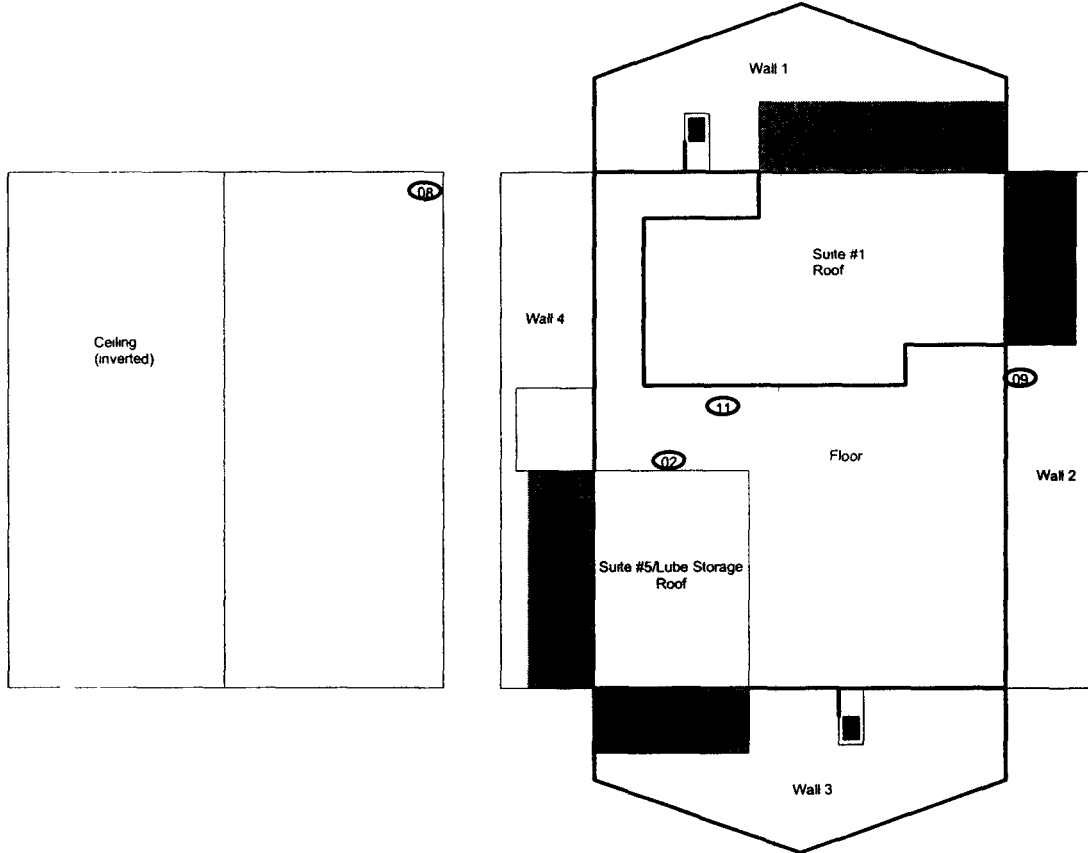
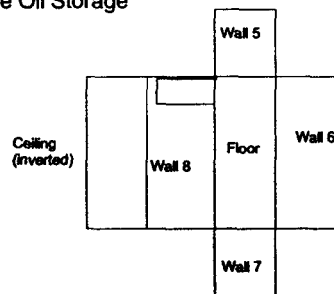
SURVEY UNIT 771019 - MAP 4 OF 4

770 Interior

Lube Oil Storage

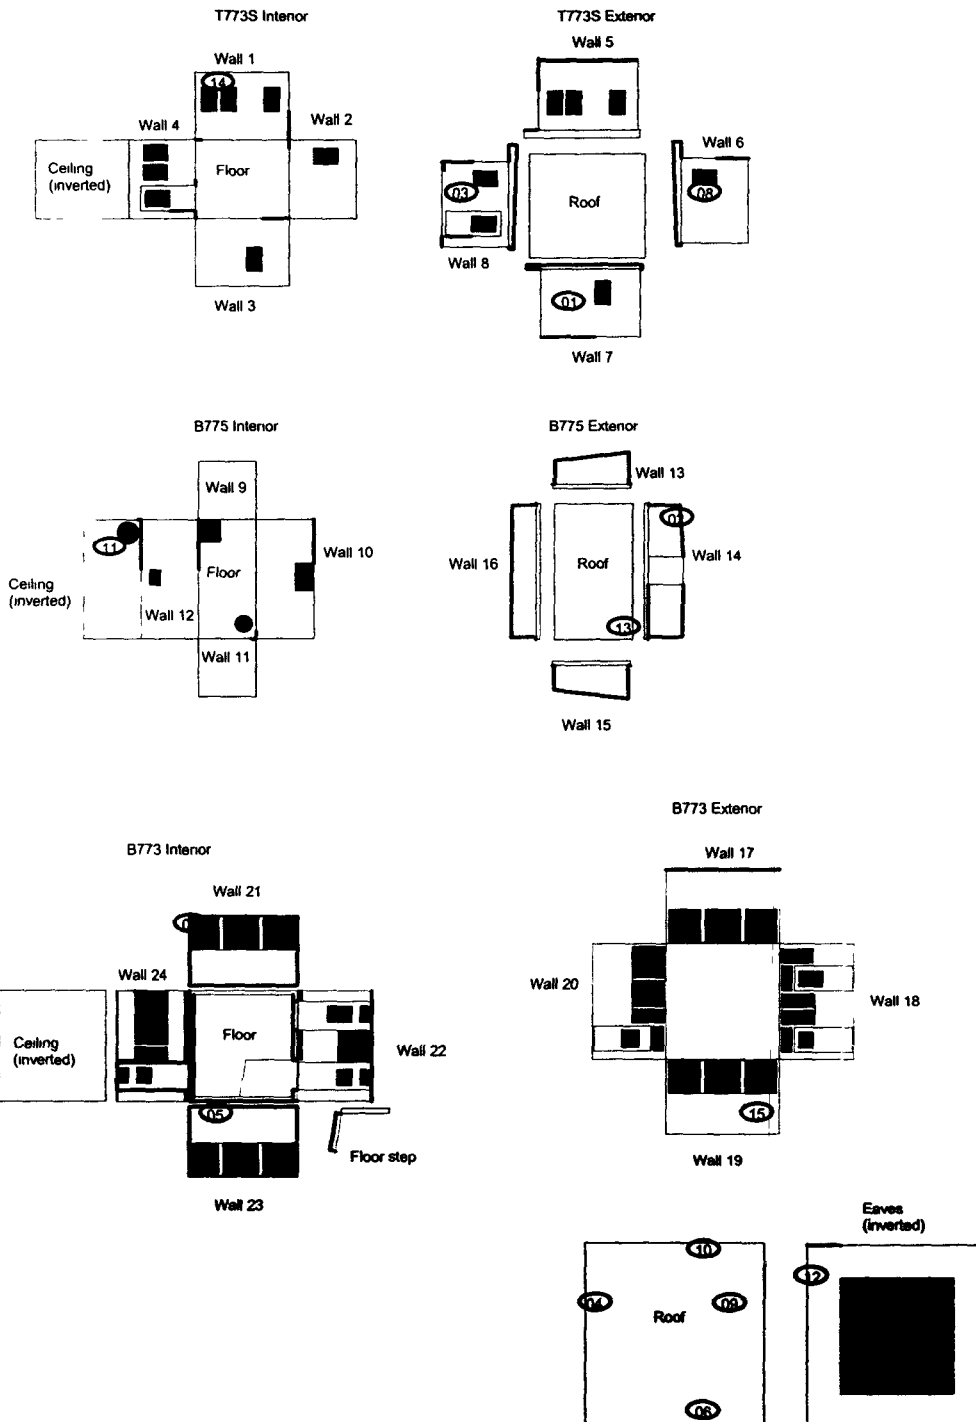
SURVEY UNIT 771020 - MAP 1 OF 1

Total Floor Area 33 sq m Total Area 300 sq m Grnd Size N/A

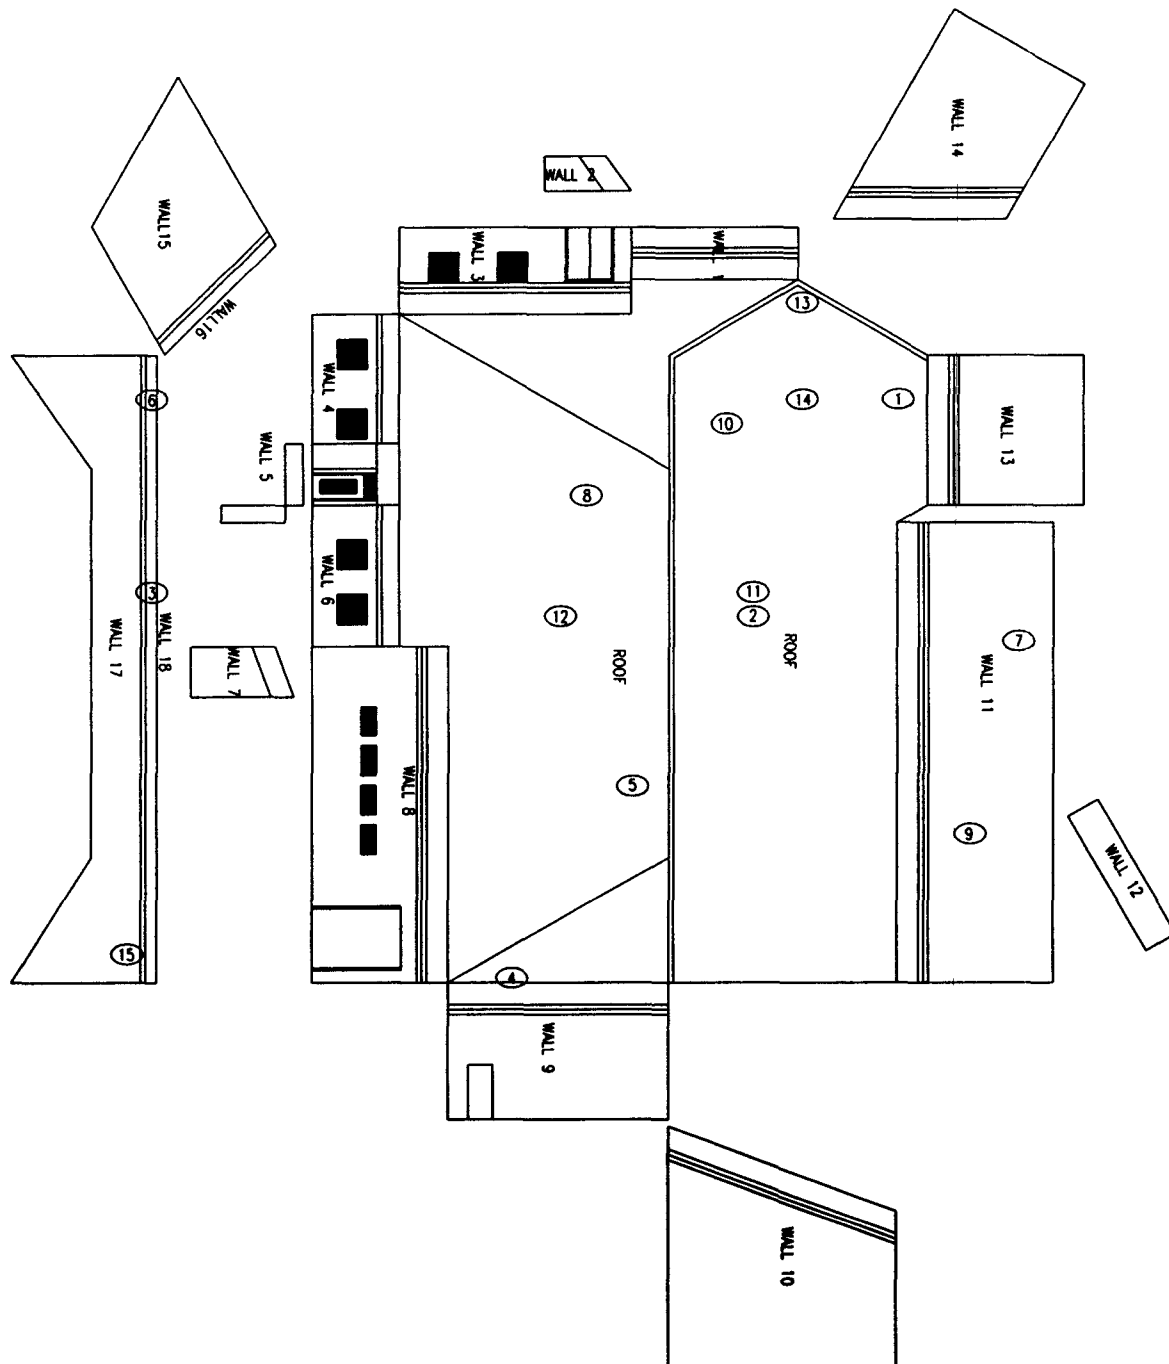
SURVEY UNIT 771 - MAP 1 OF 1

SURVEY AREA
BUILDING 8790

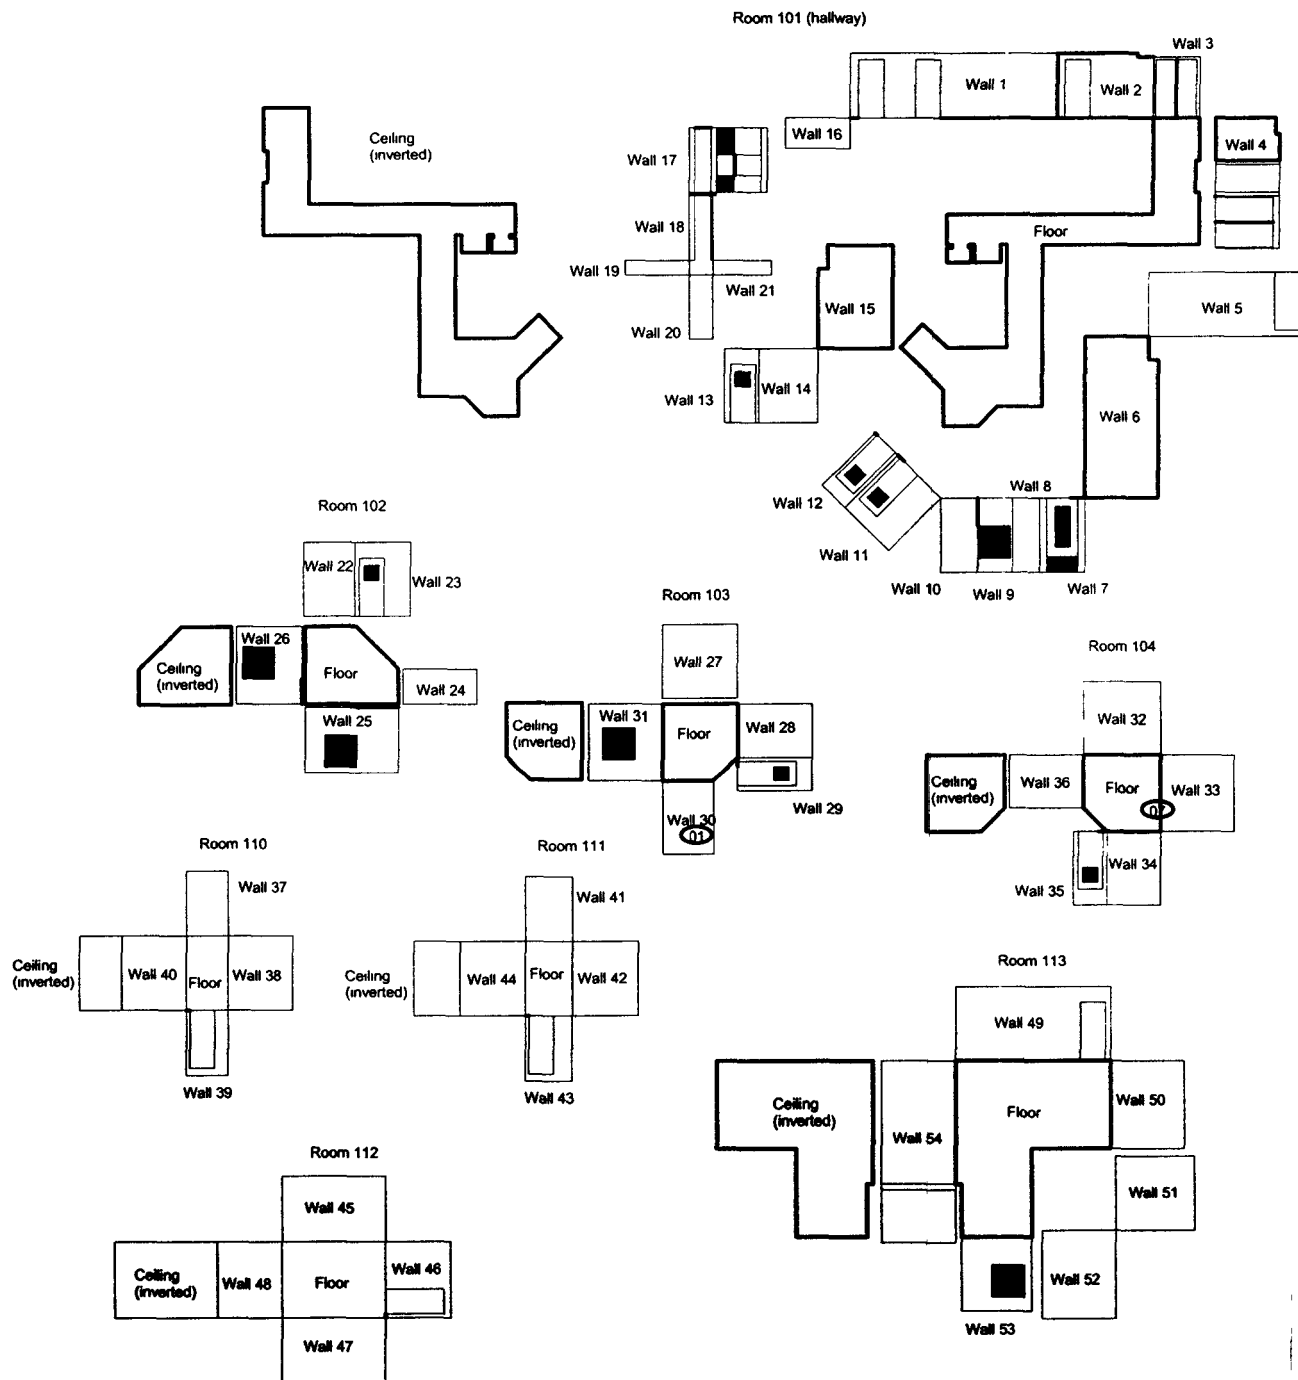
SURVEY UNIT 771022 - MAP 1 OF 5

Total Floor Area 501 sq m Total Area 2473 sq m Grid Size N/A
